Fidalgo Pool and Fitness Center Facility Audit Anacortes, WA

Counsilman · Hunsaker
AQUATICS FOR LIFE

In Association With
ARC Architects

DRAFT 2.17.17

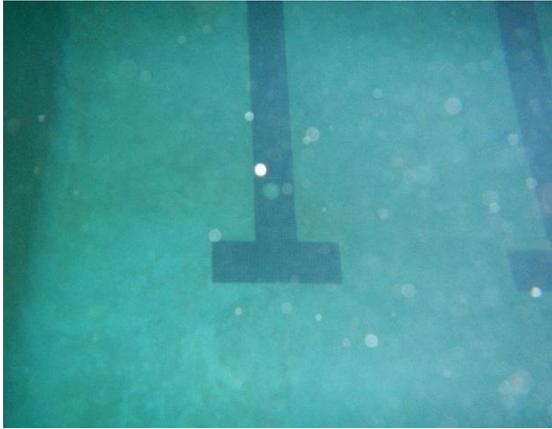
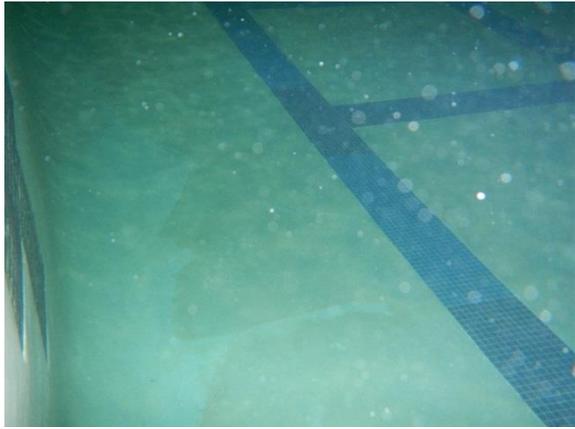
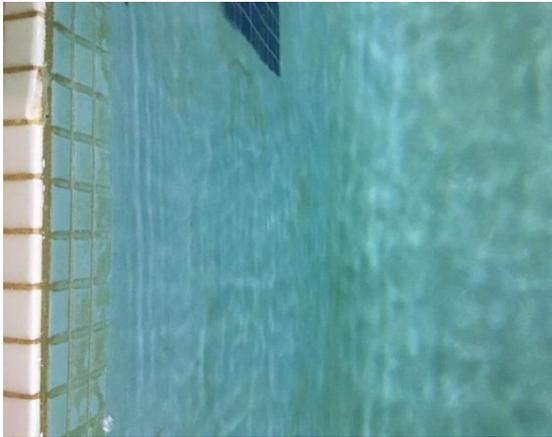
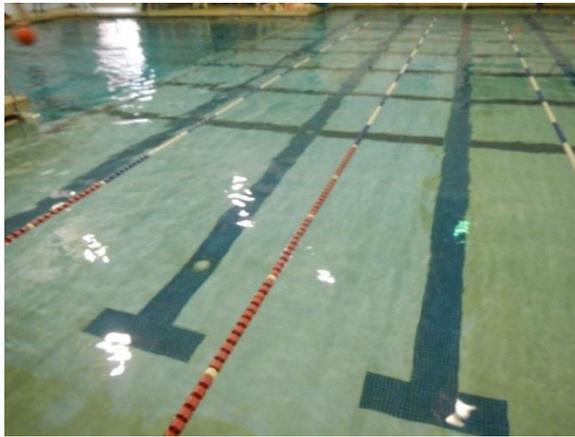
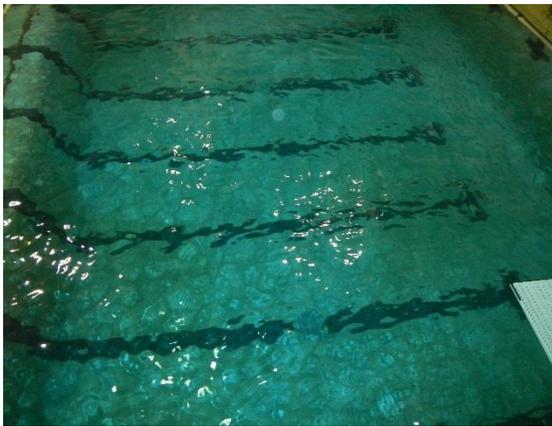
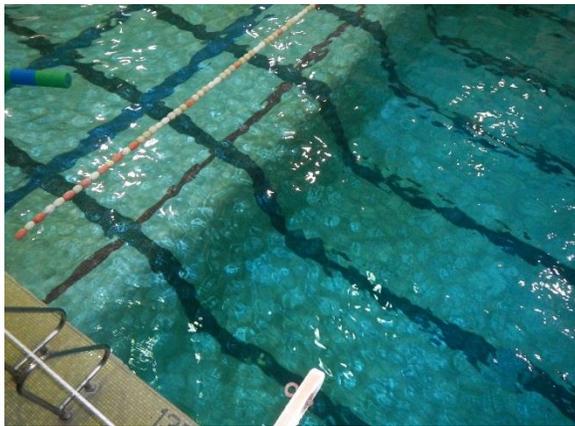
A. Structure and Finish

Constructed in 1975, the concrete pool shell is now 42 years old. The plaster pool finish features tile trim, including tile lane markings and wall targets. The gutter is tiled with 1" x 1" tiles, in between the tile pool deck and the plaster pool finish. The existing tile and plaster pool finish shows significant signs of staining, both on the pool floor and on the pool walls. There are also signs of etching of the pool surface.

Staining of the pool surface can be attributed to poor water balance or metals found in the pool water. Fill water which is high in copper or iron must be removed or severe staining can result. Staff should ensure the pool water balance is adequate to prevent scaling and corrosion. Rust colored stains can be a clear indication that the pH of the pool water is out of balance. The low pH levels are typically caused by overfeeding muriatic acid. Corroding of cast iron piping remaining in the system is another potential source for this staining. This is a common issues in indoor pools. The surface can be cleaned when the pool is drained for routine maintenance, but with the extent of the staining a new application of plaster or quartz aggregate surface such as Diamond Brite is recommended.

The pool floor drops immediately from a depth of 4 feet to a depth of 12 feet. The Washington administrative code as well as the industry standard requires a maximum slope of 1:3 from shallow water to deep water. Assuming a future slope modification occurred at the current 4 foot depth, the slope and depth of the diving well would no longer be in compliance.

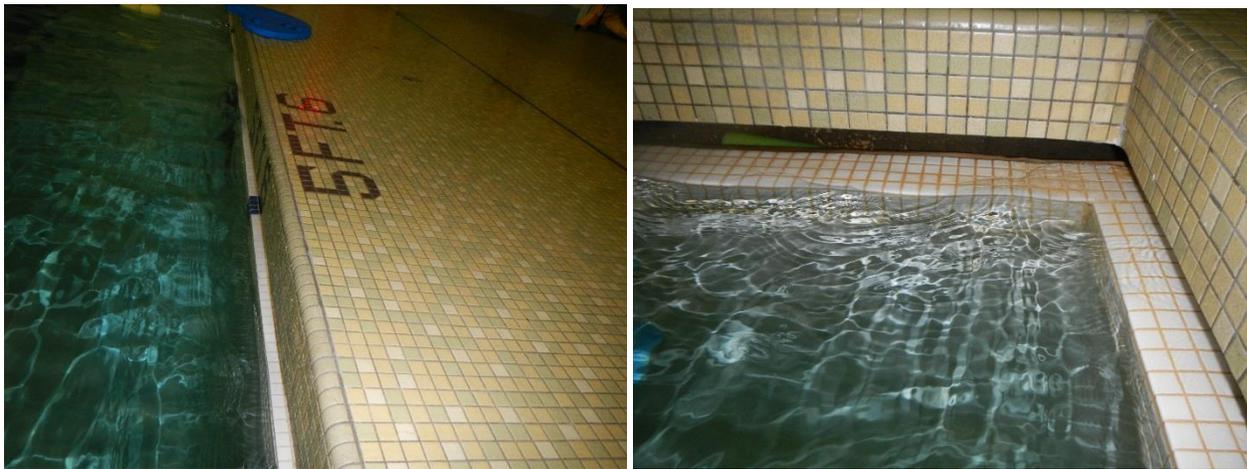
B. Perimeter Overflow System

A fully-recessed gutter with an all-tile finish is provided for surface skimming around the pool perimeter. The gutter system is in fair condition and has noticeable staining of the tile, but very few tiles were observed to have delaminated. The pool gutters drain by gravity to the surge pit through a 10" pipe that can handle up to 672 GPM at 3 ½ ft/sec. This pipe can handle 83% of the overall flow for the pool.

The current Washington Administrative Code requires overflow gutters shall be capable of continuously removing no less than 100% of the recirculated water, which is not met with the current flow rate and gutter capacity. The ability for the gutters to be able to handle 100% of the pool's flow is generally recommended and an industry design standard.

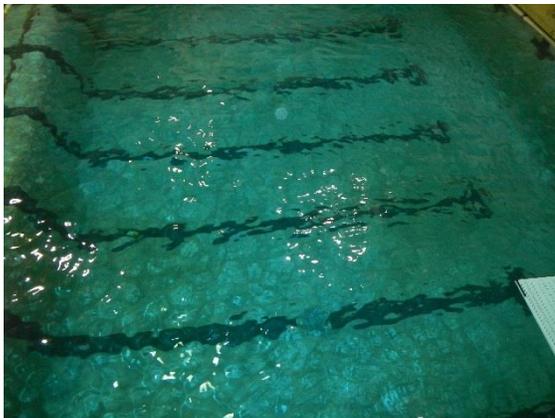
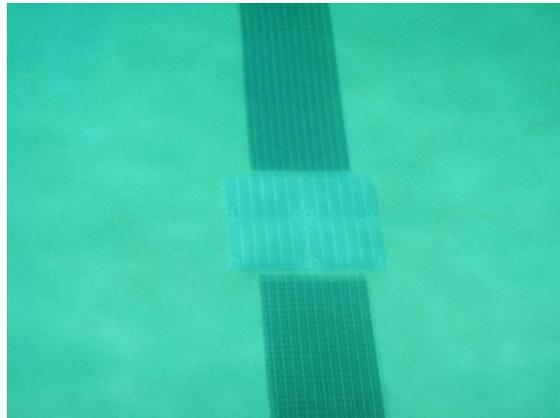
C. Main Drains

There are two (2) 24" x 24" square, fiberglass main drain covers located in the deep part of the competition pool. The main drains appear to have secured grate covers that are suction and hair entrapment certified as required by the Virginia Graeme Baker Pool and Spa Safety Act (VGB), ASME/ANSI A112.19.81.

Staff report that the main drain is gravity-fed. It is routed to a single 10in pipes that is rated 672 GPM at 3 ½ feet per second. The CH standard is for the main drain to be able to handle 100% of the circulation, which is not met by the single 10" pipe at the observed flow rate of 803 GPM. The pool drawings indicate the main drains are under suction and the Washington State Code allows for a flow of 6 feet per second. The 10" pipe could handle up to 1,343 GPM. Staff should confirm if the main drain has a direct or indirect piping connection between the main drain and the pump.

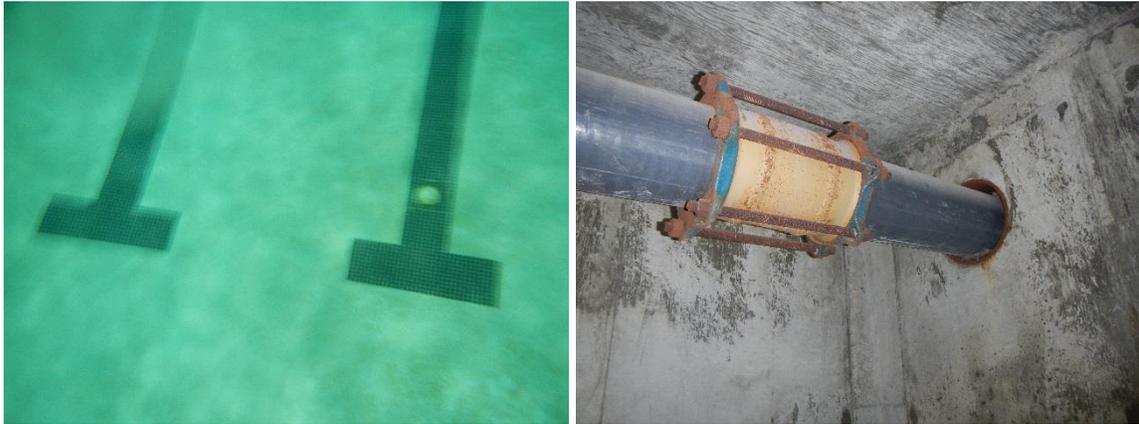
D. Inlets

The pool is equipped with 12 floor inlets in the shallow end and 6 floor inlets in the deep end. The inlets are fed with a 6" supply line that is rated for up to 812 GPM at 8 feet per second and 975 GPM at 10 feet per second. The flow rate of 803 GPM falls within the rating for the current piping.

The Washington Administrative Code requires inlets to be located on the bottom of swimming and wading pools over twenty-five hundred square feet and spa pools greater than ten thousand gallons. The current inlets meet this requirement.

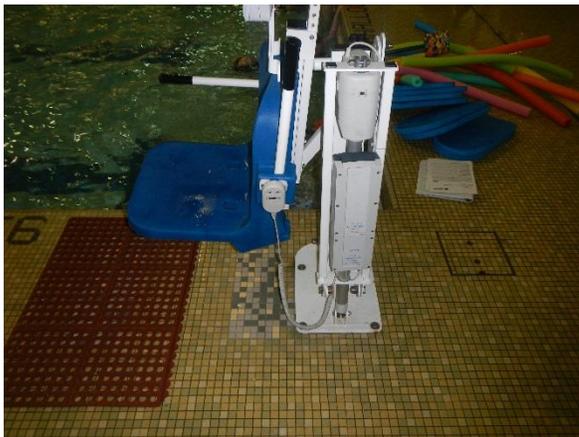
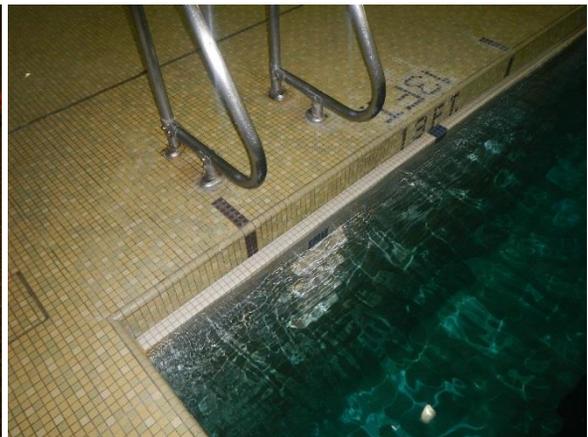
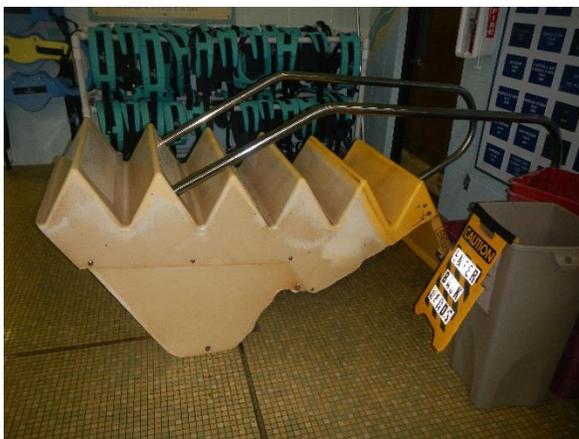
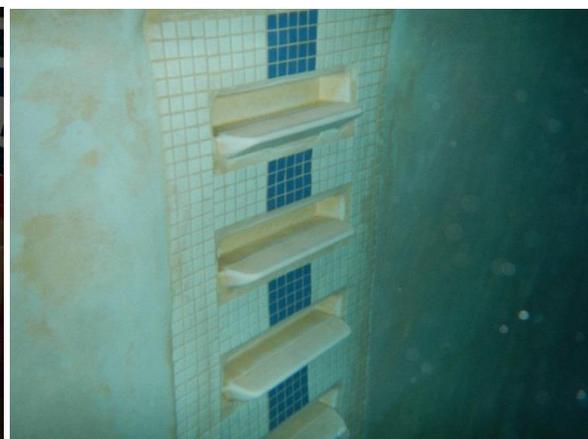
E. Ingress and Egress

The pool has deck-anchored stainless steel grab rails with embedded steps located around the pool perimeter in the wall. A compliant Americans with Disabilities Act accessible means of entry is provided for the pool. The ADA Act requires that a swimming pool with a perimeter that is more than 300' have at least two accessible means of entry and requires accessible lifts to be capable of unassisted operation from both the deck and water levels. Controls and operating mechanisms shall be unobstructed when the lift is in use.

The pool also has two fiberglass stairs with stainless steel grab rails as an alternative means of entry and exit for the pool. The handrails on the stairs are 27" apart and do not comply with the ADA standard 109.6.2 Handrails, which stipulates handrails must be within 20" and 24".

"109.6.2 Handrails. The width between handrails shall be 20" (510 mm) minimum and 24" (610 mm) maximum. Handrail extensions required by 505.10.3 shall not be required on pool stairs."

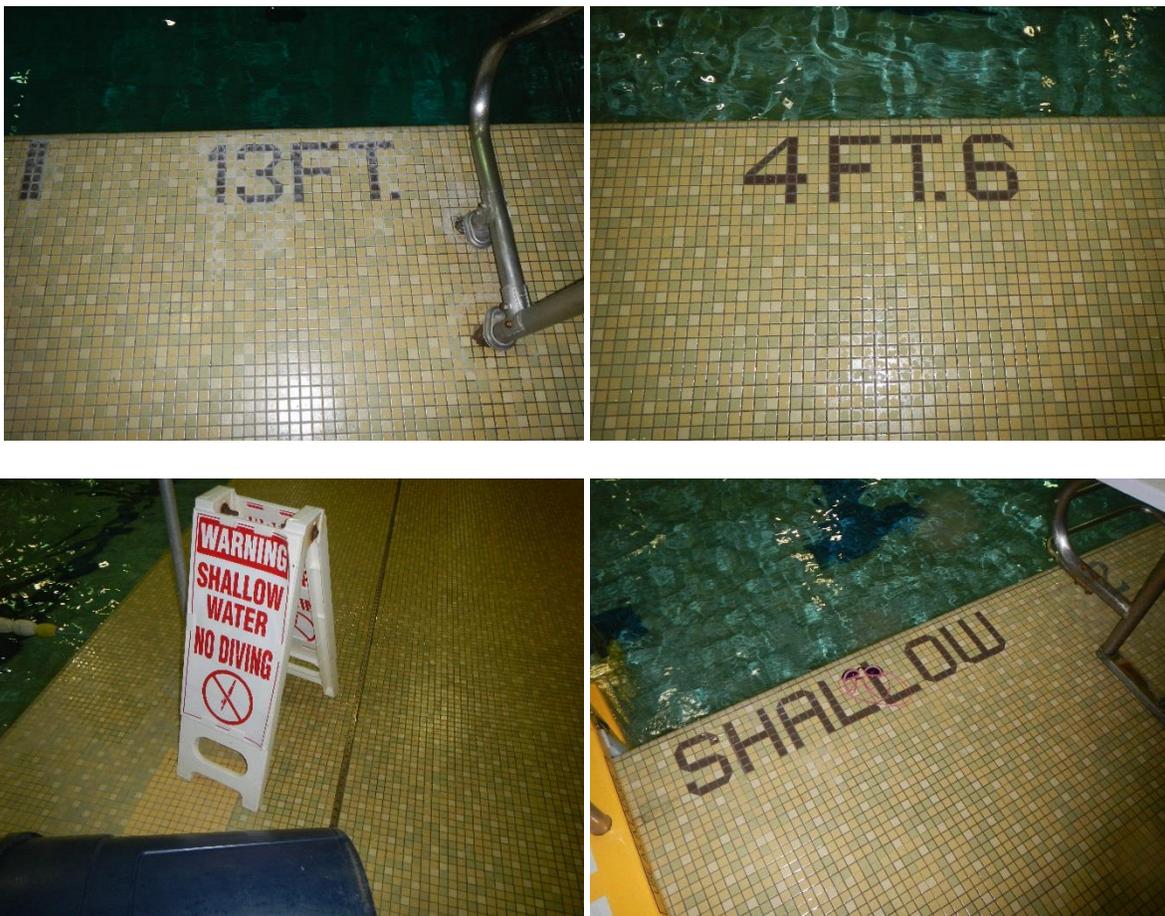
F. Depth Markings and Warning Signage

Tile horizontal depth markings are located on the tile deck around the perimeter of the pool, and inside the gutters below the deck. The deck tile markings are 7 inches tall while the gutter tile markings are 5 inches tall. This meets the Washington State Code requirement that depth markings should be “Located on the horizontal surface of pool coping or deck of pools within eighteen inches of the water's edge, easily readable while standing on the deck facing the water, in numbers at least four inches high.”

The measurements of the pool depth markings are off by roughly 2 inches. Staff reports the gutter lip was raised by two inches several years ago, but the depth markings were never adjusted to reflect the new depth.

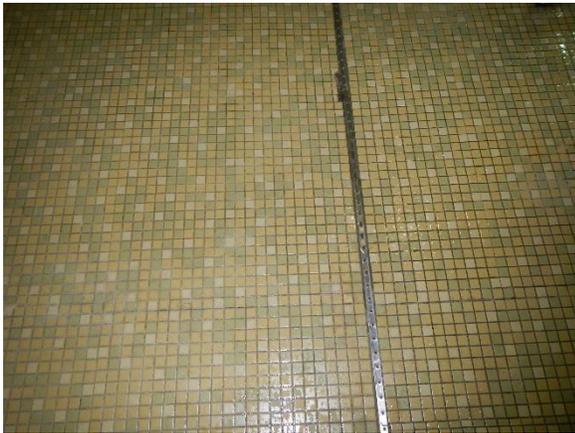
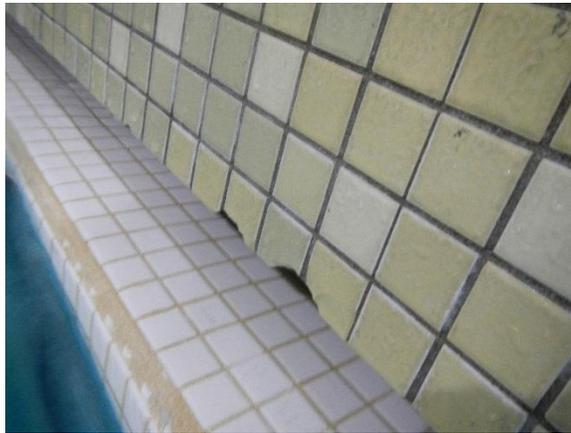
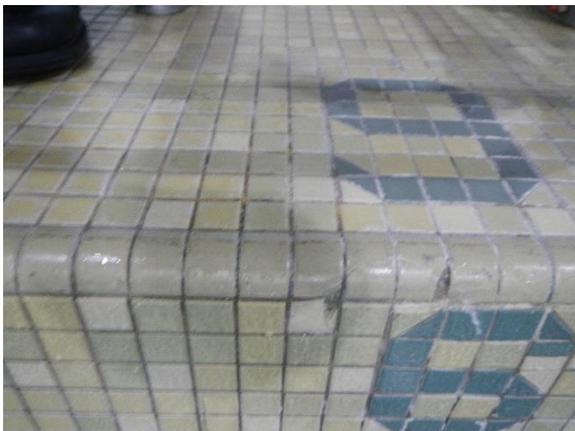
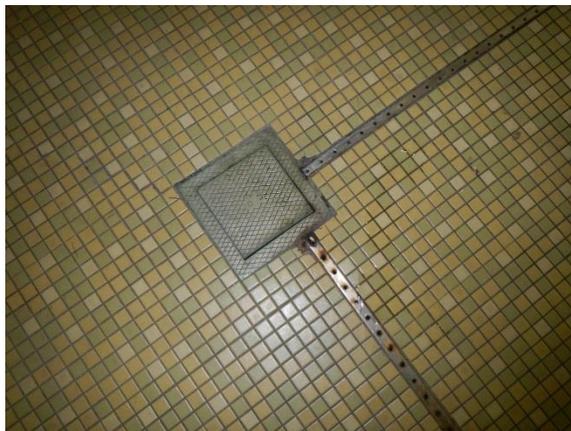
A. Deck

The pool deck is in fair condition with minimal observable cracks. The perimeter trench drain appears to be working effectively as standing water was not observed at the time of the site visit. There were areas of the deck/tile gutter connection that had sharp edges that could cause injury to pool guests, as well as a few areas where the tile had been chipped or in some instances popped off.

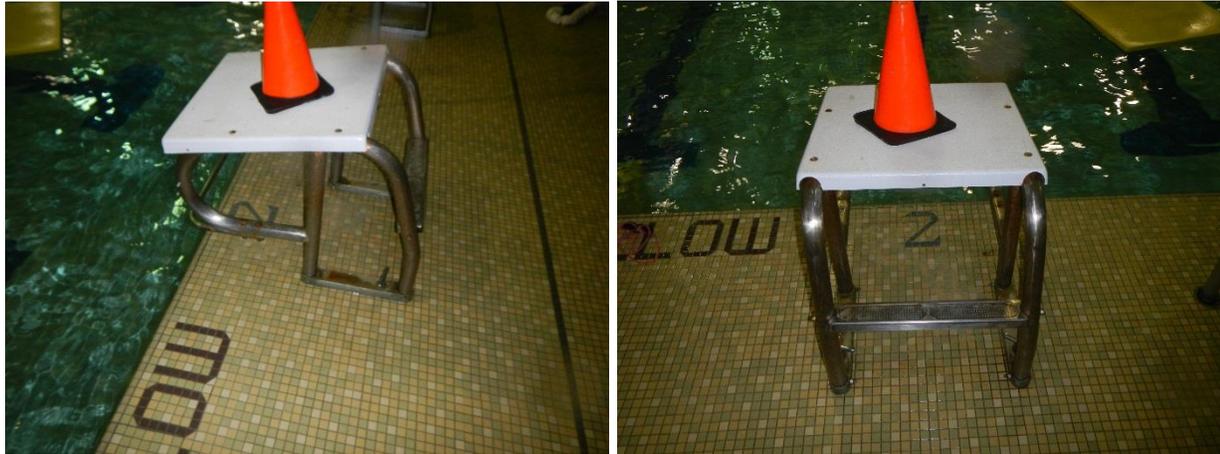
B. Starting Blocks

The pool has nine (9) starting blocks that are interchangeable and moved in between the shallow end and deep end of the pool, depending on the course length used by the competitive swim teams. This depth requirement meets the National Federation of High School Swimming (NFHS) requirement of a 4 foot minimum depth of water and that the blocks are a maximum of 30 inches above the surface of the water.

The starting blocks are an older model that does not meet the current expectations for competitive swimming. Today's industry standard for starting blocks includes dimensions of 24" x 32" for the platform. The current blocks are 22 x 22 which is close to the minimum standard for starting blocks.

These blocks meet the Washington State Code that requires protective equipment when not in use. "If water depth is less than nine feet, starting blocks must be removed or covered with protective equipment unless used by competitive swimmers trained in proper use of starting blocks."

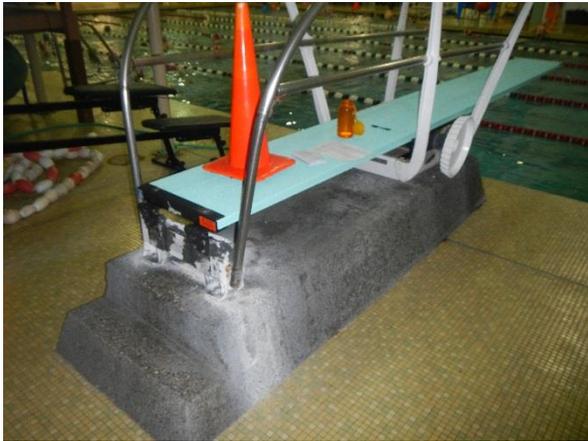
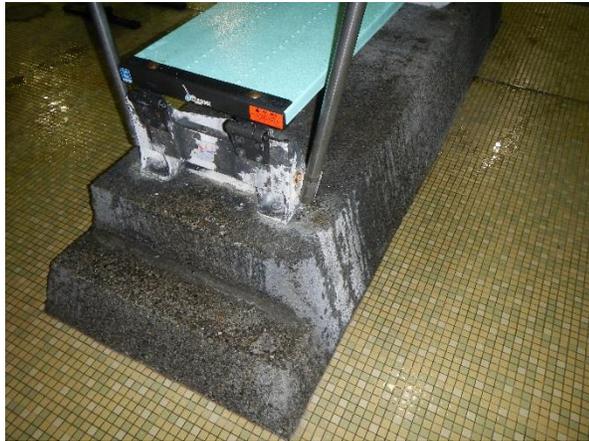
C. Diving Boards

A single 1-meter diving board is provided. The board is mounted on a concrete pedestal and is in good condition. When comparing the existing diving well dimensions to the dimensional requirements of NFHS, FINA and the NCAA, the following items were observed: (diagrams illustrating these items are found below)

The pool meets the current 1-meter depth/slope requirement for NCAA, FINA and High School.

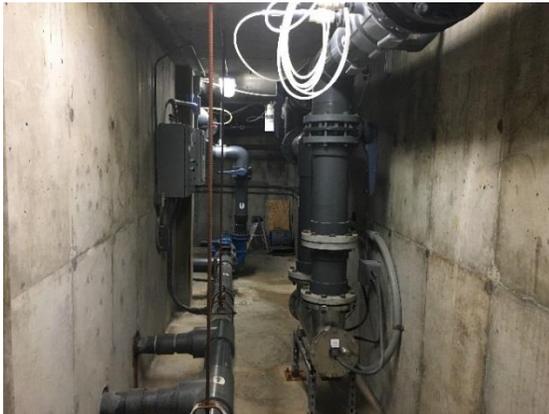
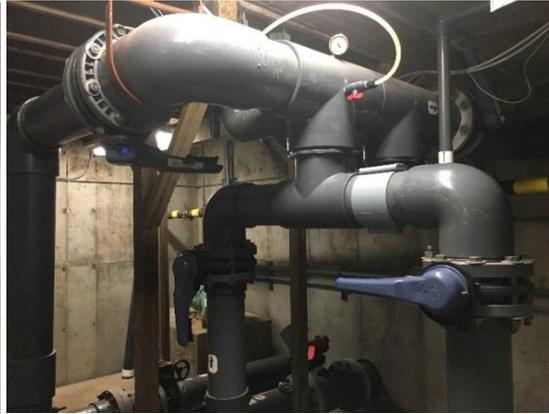
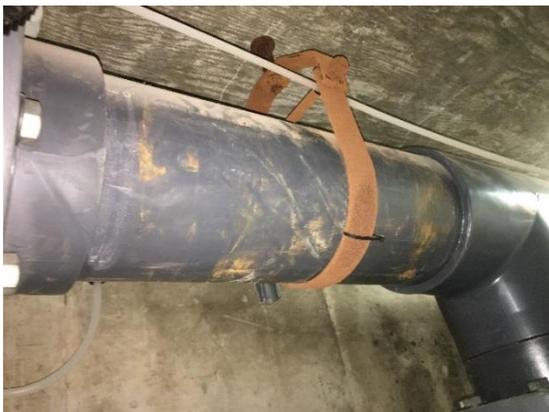
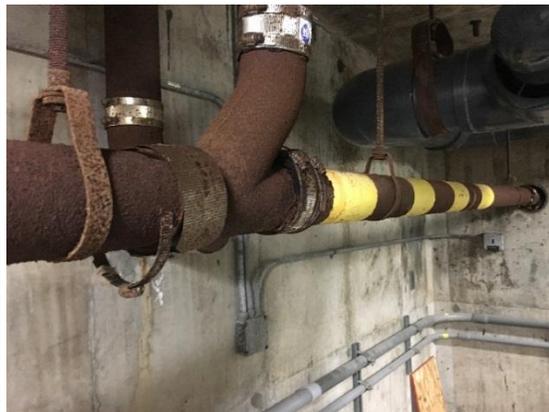
A. Piping

The visible, above ground recirculation piping for the pool in the pool mechanical room is Schedule 80 PVC piping, which is in good condition. According to staff, the original underground cast iron piping still exists and has never been replaced. Corrosion is noticeable at some of the pipe connections both the bolts and the valves, but overall the majority of piping and connections are in good condition. There is visible corrosion on several of the pipe supports throughout the mechanical room, and the pipe from the pool heater has significant corrosion. Directional arrows are provided on the exposed piping as per industry standards. The valves in the mechanical room have been replaced as necessary. Several of the overhead pipe supports show significant signs of corrosion.

With a pool of this age it is not uncommon that some of the underground piping has corroded to the point of failure. The corrosion build up on the interior of the pipes also impact pipe velocities and could be contributing to the pool surface staining. A camera test could be done to determine the integrity of the piping.

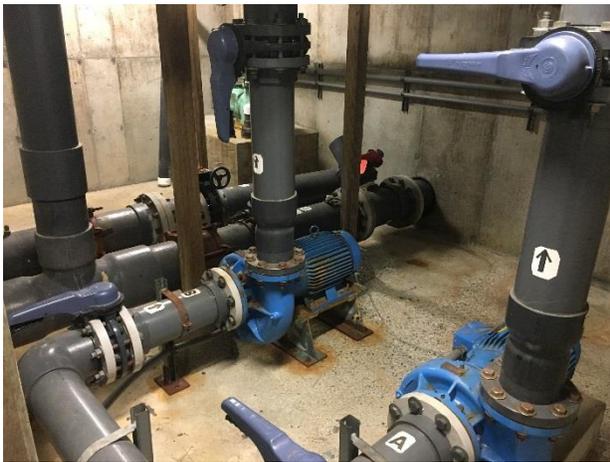
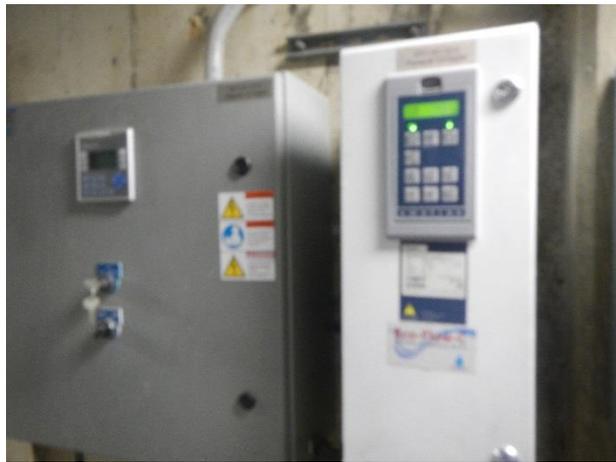
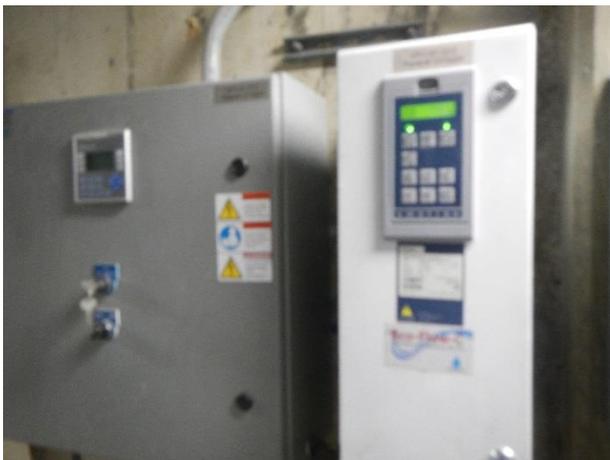
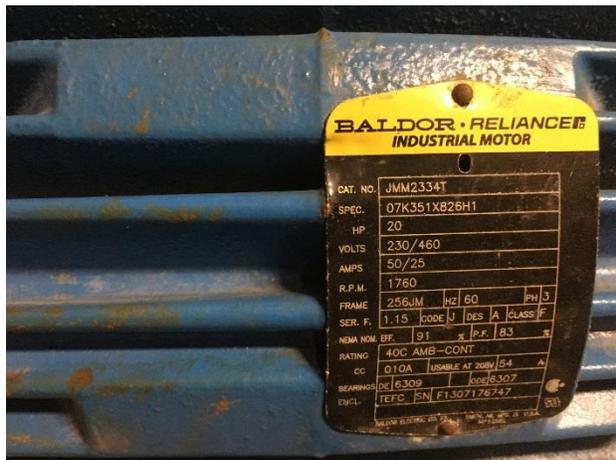
B. Pump

Both pumps and motors have been recently replaced and are alternately used on a monthly basis. They do have visible signs of corrosion, but appear to be in good condition. The recirculation pump is fed by a 20 horsepower motor. A strainer is provided for the pump as required by the administrative code. The GPM rating for the pump was not verified by nameplate during the site visit.

The pump impeller should be statically and dynamically balanced and trimmed for the specified design condition. A coating system to protect the pump cast iron from corrosion is an industry standard on all non-bronze pumps. Staff should confirm the impellers are coated to ensure their expected lifespan.

A variable frequency drive is installed on the circulation system, model Eco-Flow-C. A variable-frequency drive (VFD) is a system for controlling the rotational speed of an alternating current (AC) electric motor by controlling the frequency of the electrical power supplied to the motor. Staff report the VFD was installed in 2014 and it is operating correctly at this time.

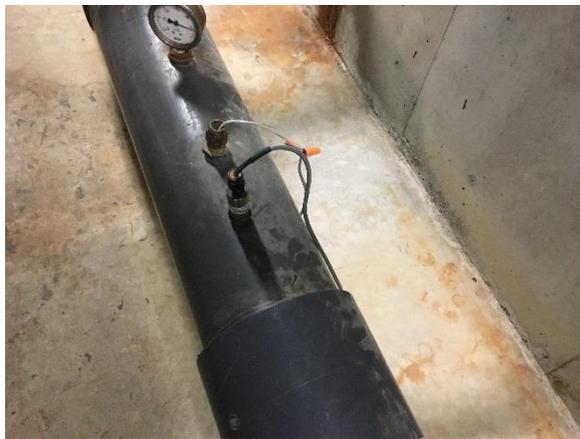
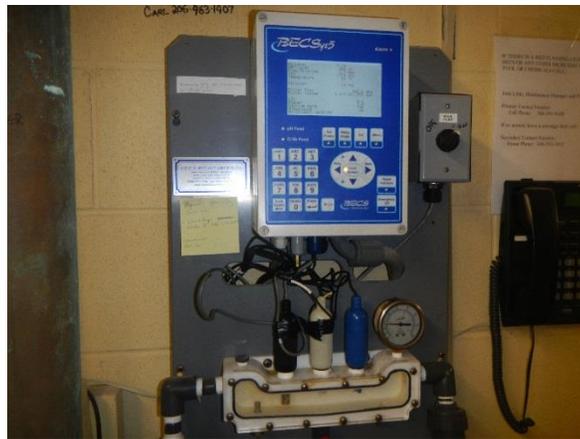
C. Flow Meter

There are two flow meters installed on the pool, one is an acrylic flow meter and is installed on the pressure piping back to the pool, downstream from the filter, which is the preferred place for mounting. The other is tied directly into the BecSys chemical controller. Flow sensors should be installed with at least ten pipe diameters downstream and five pipe diameters upstream on a straight run of piping.

The flow meter was giving a reading of 803 GPM which places the turnover at 5.8 hours. According to the Washington State Code, "Owners of swimming pools shall design and maintain water treatment recirculation rates to completely turn over the entire pool water volume of pool in six hours or less." The Fidalgo Pool meets this requirement.

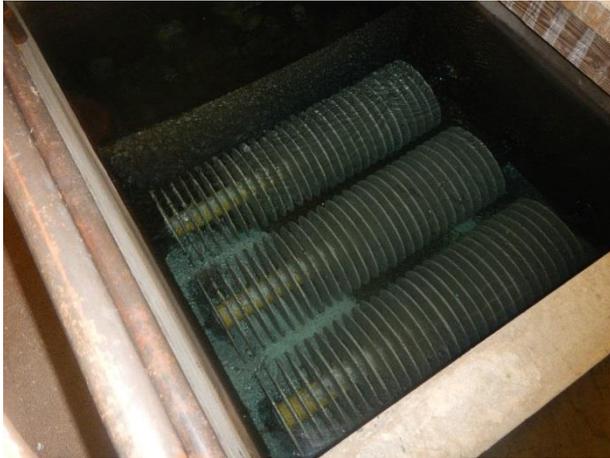
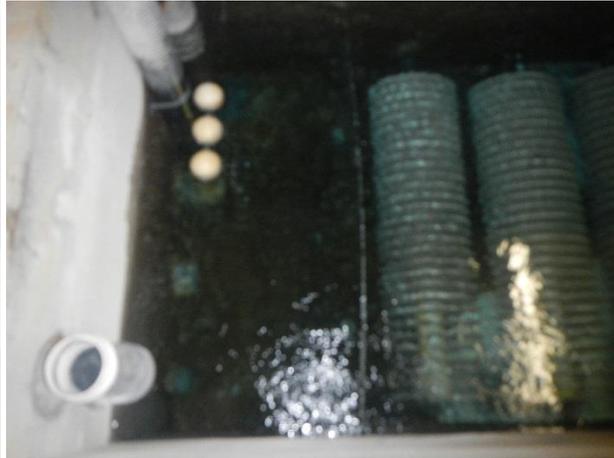
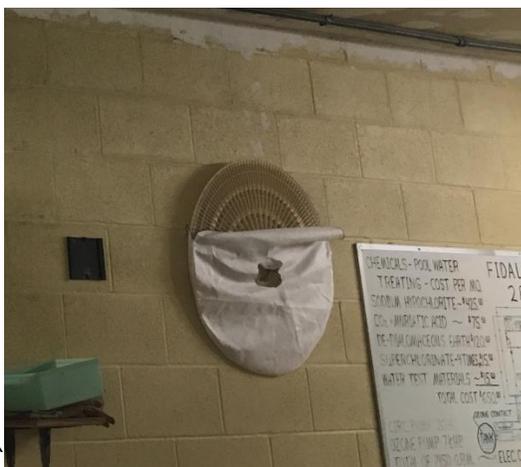
D. Filtration System / Surge Tank

The pool uses open-air vacuum Diatomaceous earth (DE) filters for its filtration. This system was installed during the initial construction. While these filters have served the facility well and provided ample water quality over the years, it is an antiquated system and should be replaced during a facility renovation with either high-rate sand filtration or regenerative media filtration.

The size and capacity of these filters could not be verified by nameplate on site during the audit, but staff notes have estimated each disc at 26 inches of diameter, equaling 121 SF of total surface area. The standard flow rate for this type of filtration system is to stay within 1 to 3 GPM/SF of surface area. With a flow rate of 803 GPM, the filtration rate is calculated at 6.6 GPM/SF which exceeds the industry standard for this type of filter by more than double.

Washington State Code requires the capacity in gallons of the surge tank to equal the square footage of the pool. This would require the surge tank to hold 5,040 gallons.

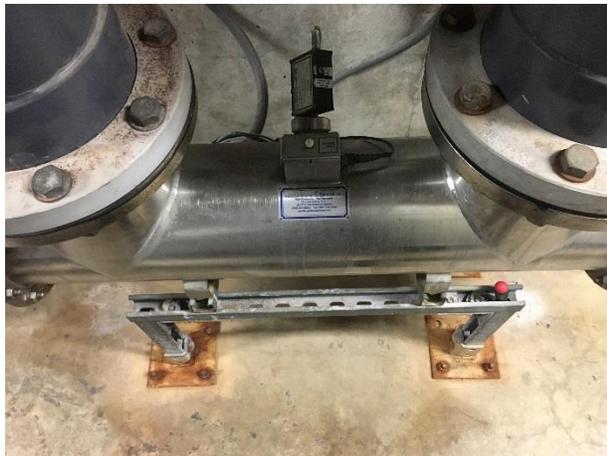
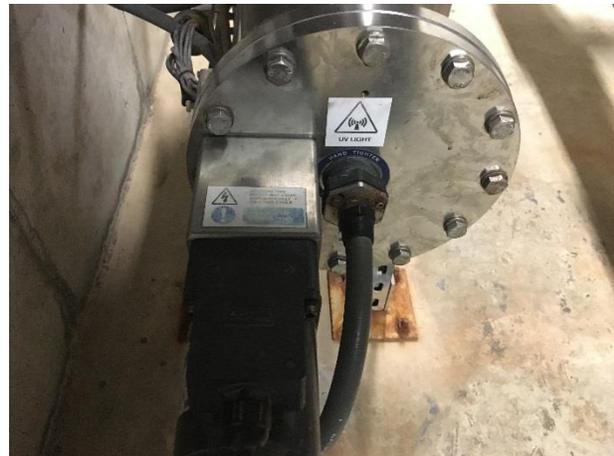
E. UV System

The pool mechanical system contains a Hanovia Ultraviolet Light Water Treatment System (UV). UV becomes beneficial in water treatment applications due to its ability to eliminate combined chlorine (also known as “chloramines”) and kill chlorine resistant pathogens. While UV does break down free chlorine, the good form of chlorine used for pool disinfection, it is still highly recommended due to its ability to eliminate chloramines. Lower levels of chloramines lessens the corrosive off-gassing which attributes to the corrosion of deck equipment, HVAC, and internal structures of some facilities. Additionally, chloramines are typically responsible for the odor and irritation experienced by athletes, coaches and staff.

Eliminating chloramines creates a healthier and more enjoyable environment for facility users and staff. A UV system should be included in any future mechanical system renovations, or the construction of a new aquatic facility. Not only will UV systems kill pathogens and chloramines, but they will also eventually provide cost savings. It is common for a UV units to help lengthen and enhance the life expectancy of building materials, dehumidification units, etc. due to the elimination of combined chlorine before it is released into the air and causes corrosion of these materials.

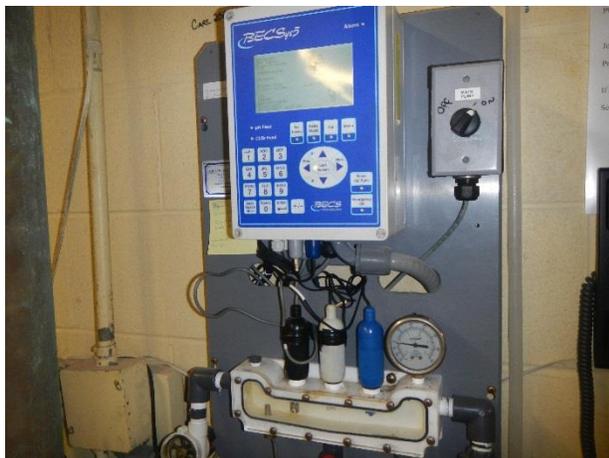
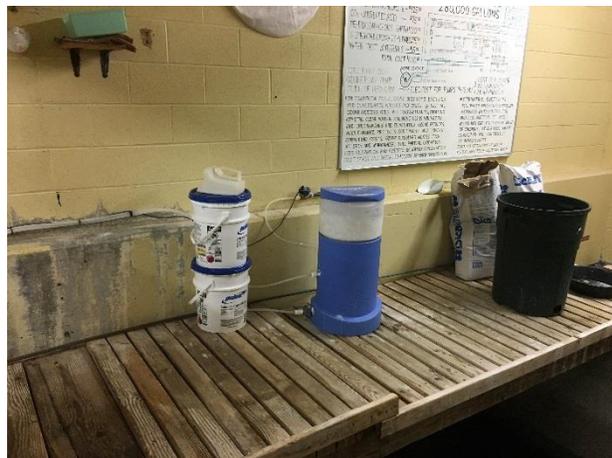
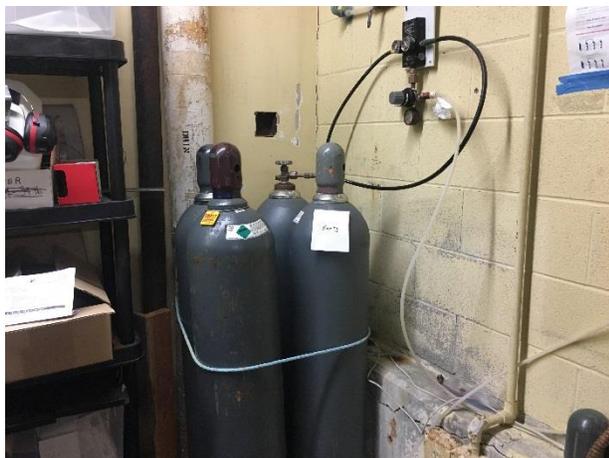
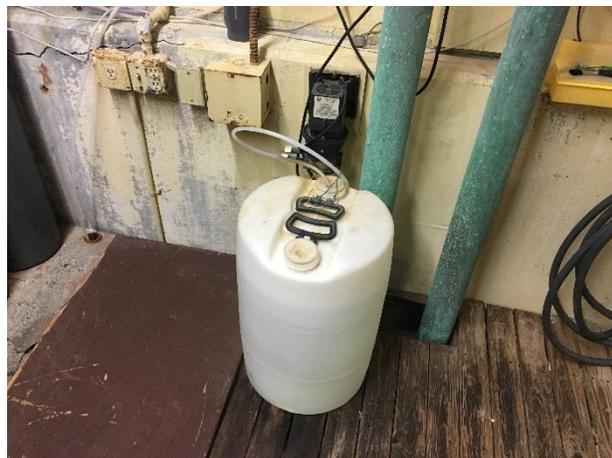
F. Chemical Treatment System

Currently the pool chemicals are located in the same area as the pool mechanical room. The pool is sanitized with Calcium hypochlorite (tablet chlorine) through a Pulsar 3 system and both CO2 and muriatic acid are used as the pH buffer. The 50 lb. buckets of calcium hypochlorite are stored inside the pool mechanical room on a platform above the surge tank. The muriatic acid and CO2 are stored in the same area, next to the chemical controller.

According to the Washington State Code, "Owners shall provide a separate chemical storage area or room that conforms to manufacturer's requirements for each chemical used in the pool area." A separate dedicated and ventilated chemical storage room for both the sanitizer and pH buffer is recommended and is the current industry standard. The existing chemical storage area does not meet the current requirement or standard. Dedicated chemical storage spaces should be included in any future plans, whether for a renovation or a new facility.

The pool is controlled by a BecSys 5 chemical controller. The chemical controller automatically adds chlorine and the pH buffer, maintaining the proper chemical balance throughout each day. The controller is in good working condition and is appropriate for this type of usage.

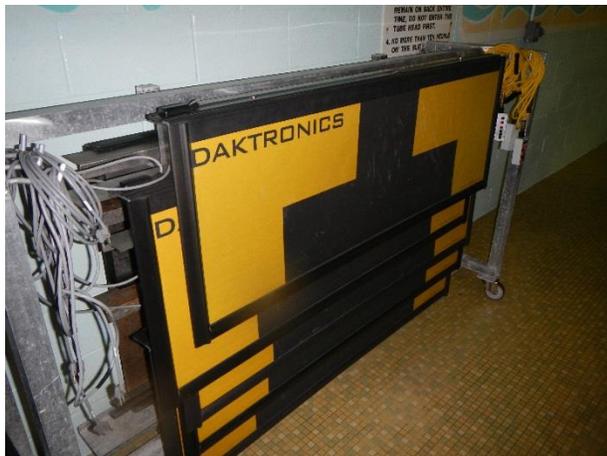
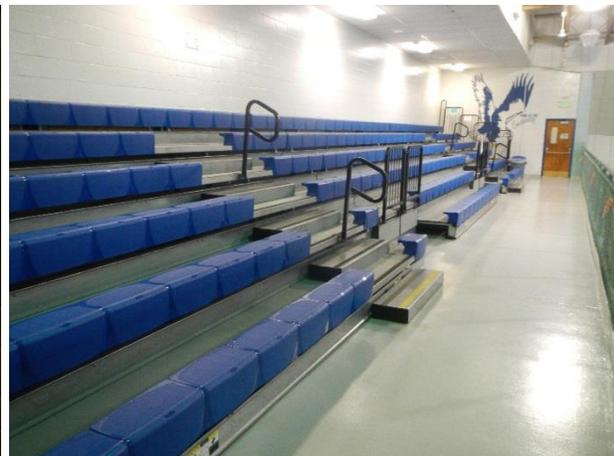
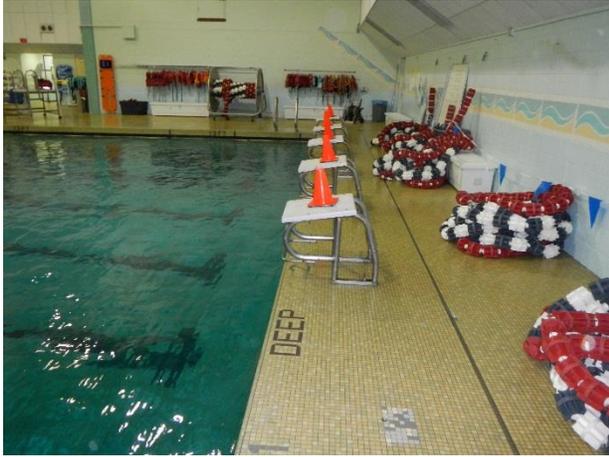
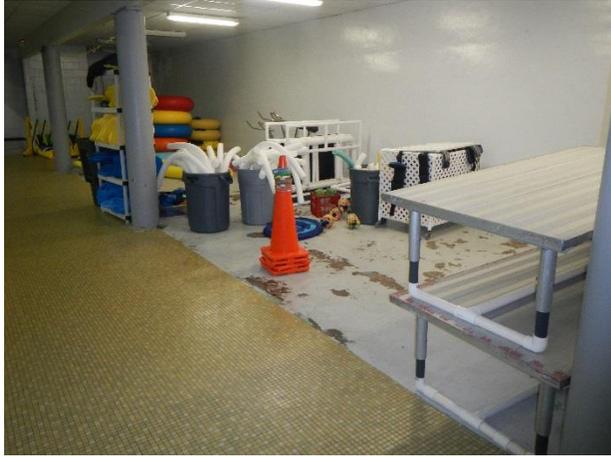
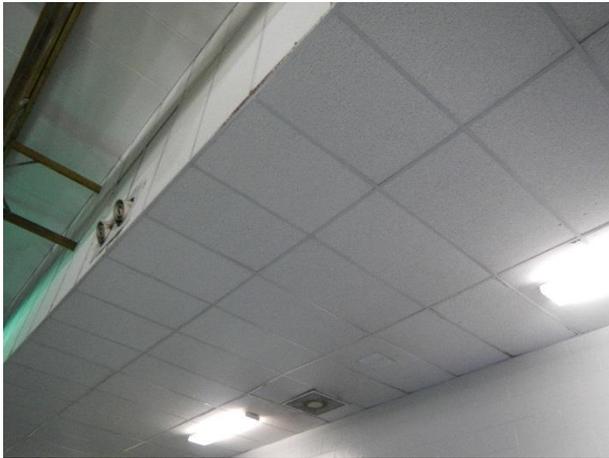
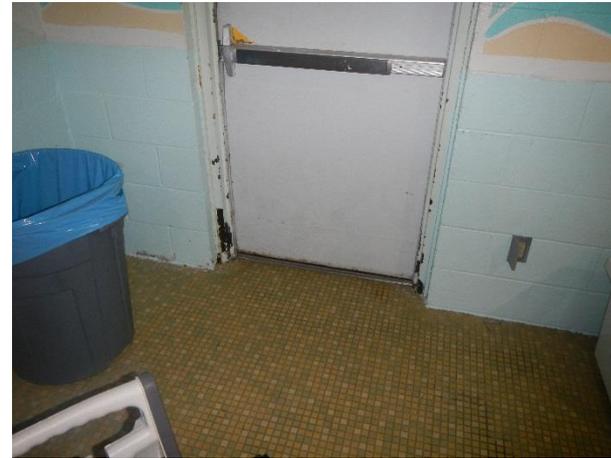
G. General Observations

- There is not enough storage space at the Fidalgo Pool and Fitness Center. Currently the pool deck is used for storage for items such as the Daktronics timing equipment, lane ropes for the 25 meter course length, and swim lesson equipment (such as kickboards, floats and underwater benches).

- The deck space behind the starting blocks on the 25 meter course length is insufficient. Swim team staff report that during swim meets, there is not adequate room for timers, swimmers and coaches in this area, specifically during relay swims.

- The first two rows in the upstairs spectator seating for the swimming pool are not able to see the first two lanes during swim meets.
- The ceiling material in the Fidalgo Pool area is not what is typically specified for indoor natatorium environments. The ceiling panels in a natatorium are usually made of galvanized steel with a coating of high-build epoxy coating. Other materials can be precast concrete, wood or aluminum. As with other materials in a natatorium, acoustical wall and ceiling must be corrosion resistant and interface with a vapor barrier, if necessary.

- User groups reported the air quality in the second-level spectator seating area is poor. Spectator areas should have higher air velocities of cool air (40 ft/min to 50 ft/min). Ceiling fans have also been used to improve spectator comfort. High velocity warm air in the face of spectators can be uncomfortable; therefore, cool air should be introduced over any raised spectator gallery for a major venue facility.

- Significant corrosion exists around the door frame on the east wall of the natatorium.
