**Agenda for the Special Meeting of
The Board of Commissioners**

**Fidalgo Pool and Fitness Center
Facility Audit
Anacortes, WA**

Counsilman • Hunsaker
AQUATICS FOR LIFE

In Association With
ARC Architects

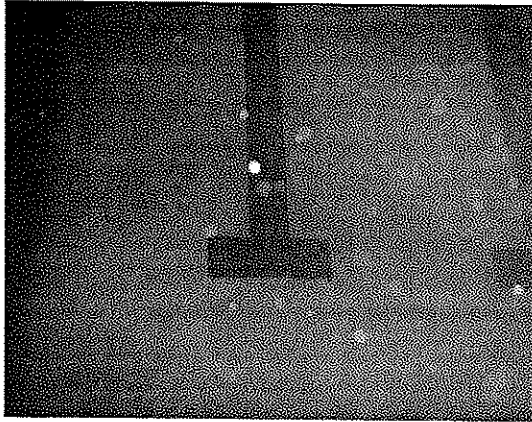
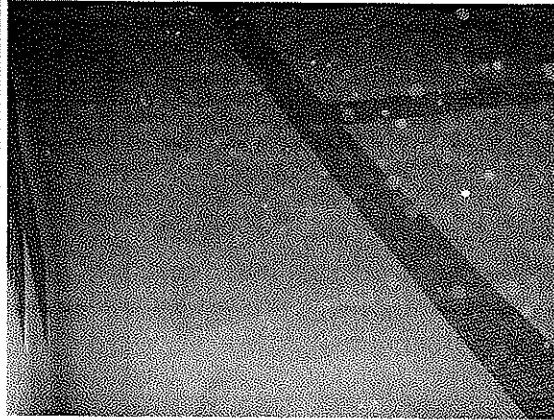
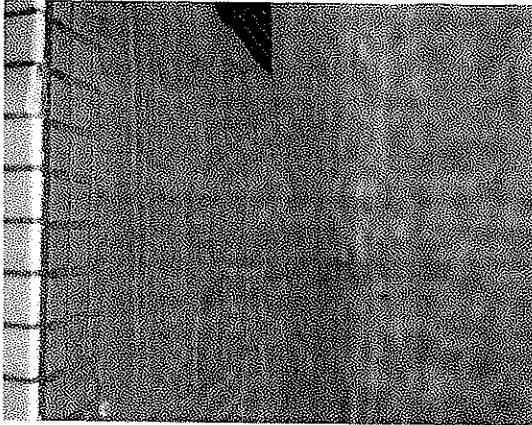
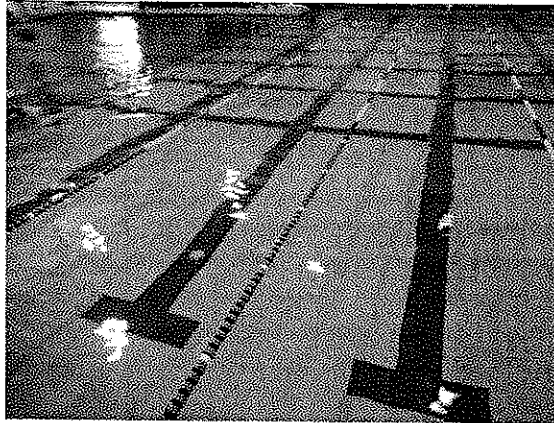
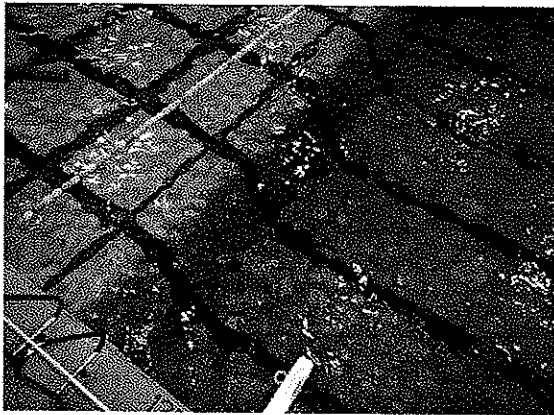
A. Structure and Finish

Constructed in 1975, the concrete pool shell is now 42 years old. The plaster pool finish features tile trim, including tile lane markings and wall targets. The gutter is tiled with 1" x 1" tiles, in between the tile pool deck and the plaster pool finish. The existing tile and plaster pool finish shows significant signs of staining, both on the pool floor and on the pool walls. There are also signs of etching of the pool surface.

Staining of the pool surface can be attributed to poor water balance or metals found in the pool water. Fill water which is high in copper or iron must be removed or severe staining can result. Staff should ensure the pool water balance is adequate to prevent scaling and corrosion. Rust colored stains can be a clear indication that the pH of the pool water is out of balance. The low pH levels are typically caused by overfeeding muriatic acid. Corroding of cast iron piping remaining in the system is another potential source for this staining. This is a common issues in indoor pools. The surface can be cleaned when the pool is drained for routine maintenance, but with the extent of the staining a new application of plaster or quartz aggregate surface such as Diamond Brite is recommended.

Staff report that some sources of iron that may have contributed to the pool stains have been removed in the last few years, including a rusted chain fall system and two large iron brackets in the surge tank that supported the pool water fill tube and the pool water level float tube.

The pool floor drops immediately from a depth of 4 feet to a depth of 12 feet. The Washington administrative code as well as the industry standard requires a maximum slope of 1:3 from shallow water to deep water. Assuming a future slope modification occurred at the current 4 foot depth, the slope and depth of the diving well would no longer be in compliance.

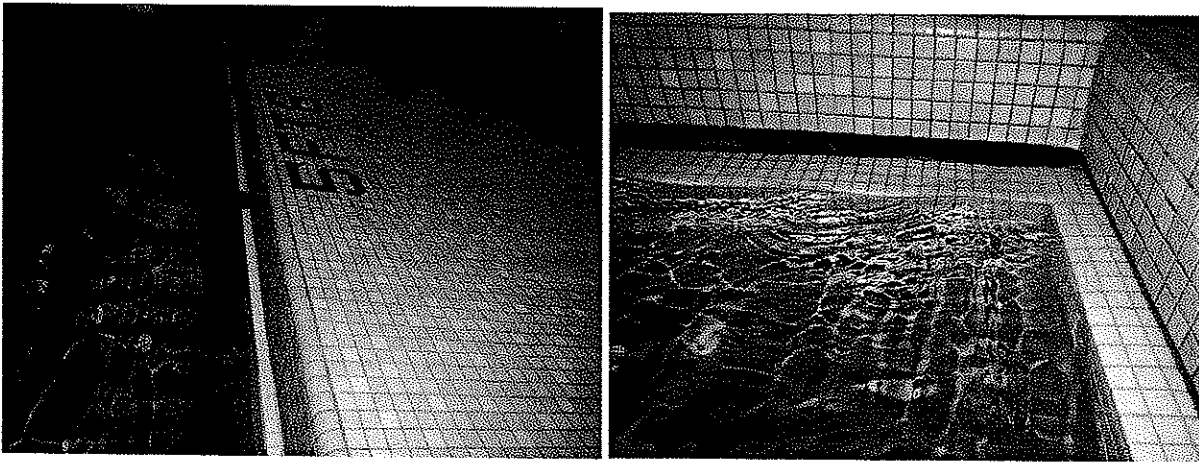
B. Perimeter Overflow System

A fully-recessed gutter with an all-tile finish is provided for surface skimming around the pool perimeter. The gutter system is in fair condition and has noticeable staining of the tile, but very few tiles were observed to have delaminated. The pool gutters drain by gravity to the surge pit through a 10" pipe that can handle up to 672 GPM at 3 ½ ft/sec. This piping is rated to handle 83% of the overall flow for the pool.

The current Washington Administrative Code requires overflow gutters shall be capable of continuously removing no less than 100% of the recirculated water, which is not met with the current flow rate and gutter capacity. The ability for the gutters to be able to handle 100% of the pool's flow is generally recommended and an industry design standard.

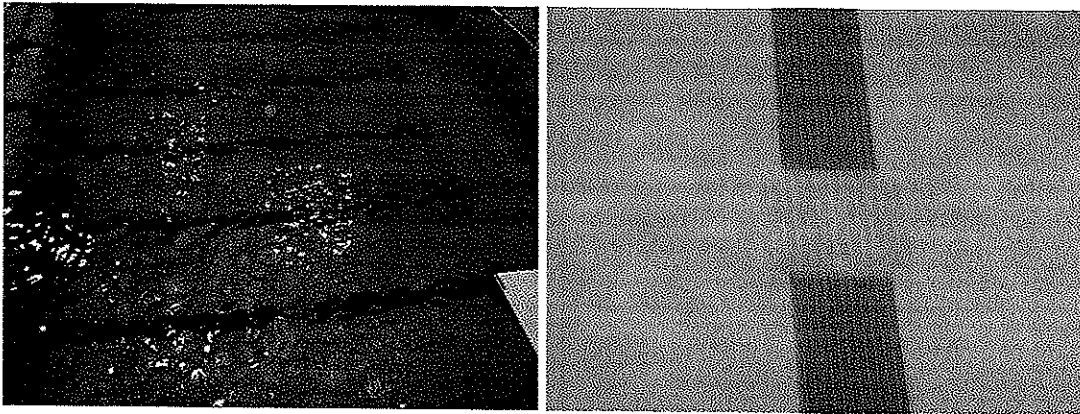
C. Main Drains

There are two (2) 24" x 24" square, fiberglass main drain covers located in the deep part of the competition pool. The main drains appear to have secured grate covers that are suction and hair entrapment certified as required by the Virginia Graeme Baker Pool and Spa Safety Act (VGB), ASME/ANSI A112.19.81.

All main drains with dimensions 18" x 23" or smaller are classified as "blockable" and must have a VGB stamped and certified "unblockable" grate cover with tamper proof screws. The federal regulations of VGB were passed by Congress in 2008 and are designed to reduce the potential for suction and hair entrapment in commercial swimming pools at all suction outlets (e.g. main drains, skimmer equalizer lines, etc.). The Consumer Product Safety Commission (CPSC) is tasked with federally enforcing all VGB regulations, but due to the vast number of commercial swimming pools in the United States, enforcement most commonly is the responsibility of the local governing agencies (e.g. public health departments, building departments, etc.).

Staff report that the main drain is gravity-fed. It is routed to a single 10in pipes that is rated 672 GPM at 3 ½ feet per second. The CH standard is for the main drain piping to be rated to handle 100% of the circulation, which is not met by the single 10" pipe at the observed flow rate of 803 GPM.

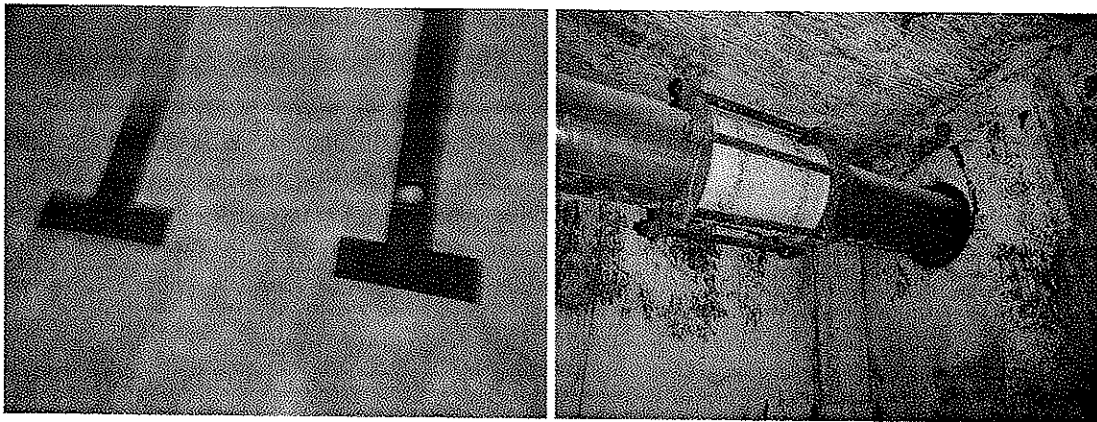
D. Inlets

The pool is equipped with 12 floor inlets in the shallow end and 6 floor inlets in the deep end. The inlets are fed with a 8" supply line that is rated for up to 812 GPM at 8 feet per second and 975 GPM at 10 feet per second. The flow rate of 803 GPM falls within the rating for the current piping.

The Washington Administrative Code requires inlets to be located on the bottom of swimming and wading pools over twenty-five hundred square feet and spa pools greater than ten thousand gallons. The current inlets meet this requirement.

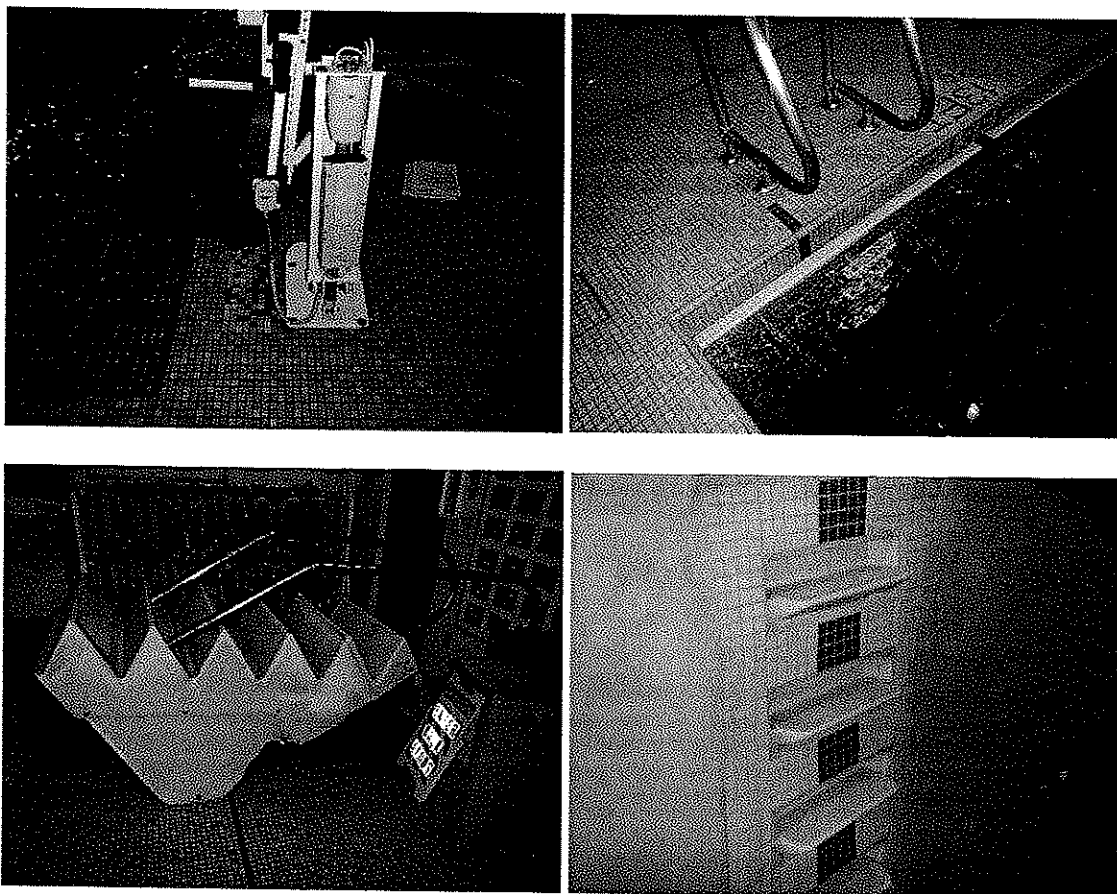
E. Ingress and Egress

The pool has deck-anchored stainless steel grab rails with embedded steps located around the pool perimeter in the wall. A compliant Americans with Disabilities Act accessible means of entry is provided for the pool. The ADA Act requires that a swimming pool with a perimeter that is more than 300' have at least two accessible means of entry and requires accessible lifts to be capable of unassisted operation from both the deck and water levels. Controls and operating mechanisms shall be unobstructed when the lift is in use.

The pool also has two fiberglass stairs with stainless steel grab rails as an alternative means of entry and exit for the pool. The handrails on the stairs are 27" apart and do not comply with the ADA standard 1009.6.2 Handrails, which stipulates handrails must be within 20" and 24".

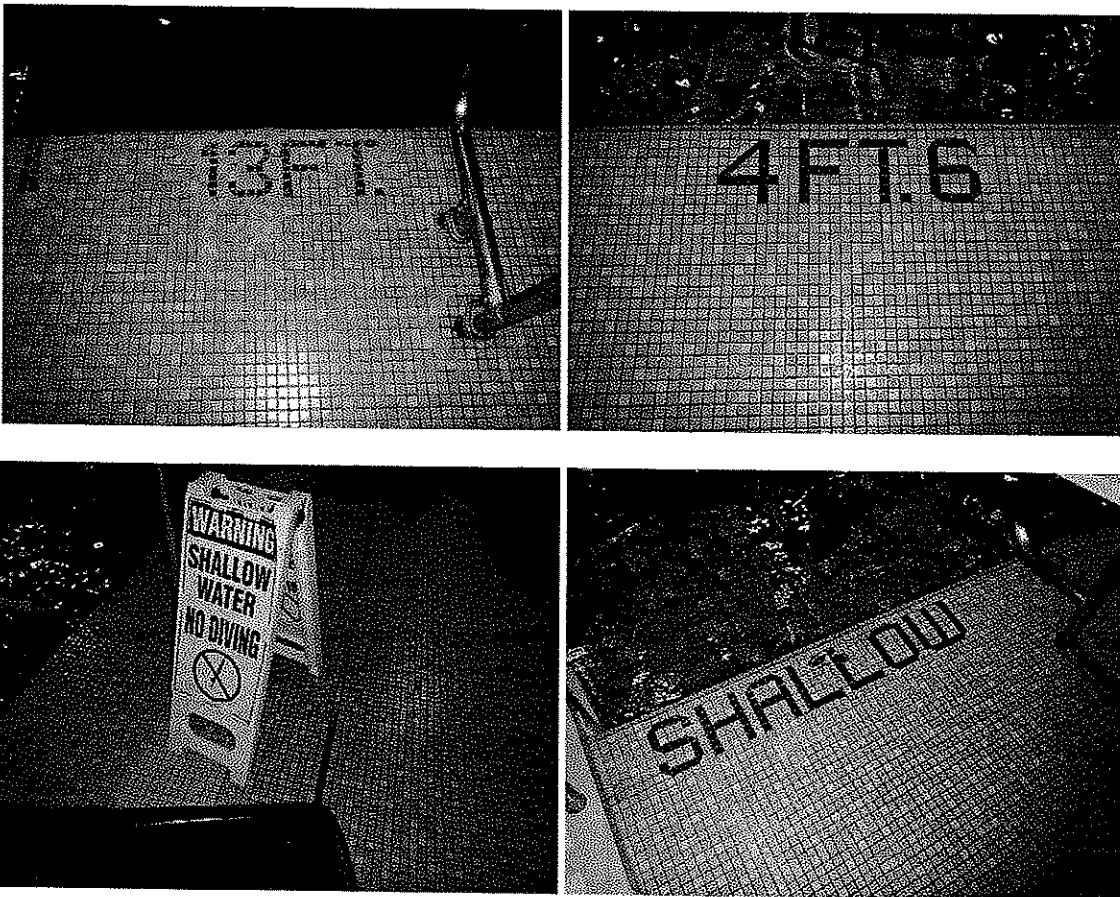
F. Depth Markings and Warning Signage

Tile horizontal depth markings are located on the tile deck around the perimeter of the pool, and inside the gutters below the deck. The deck tile markings are 7 inches tall while the gutter tile markings are 5 inches tall. This meets the Washington State Code requirement that depth markings should be "Located on the horizontal surface of pool coping or deck of pools within eighteen inches of the water's edge, easily readable while standing on the deck facing the water, in numbers at least four inches high."

The measurements of the pool depth markings are off by roughly 2 inches. Staff reports the gutter lip was raised by two inches several years ago, but the depth markings were never adjusted to reflect the new depth.

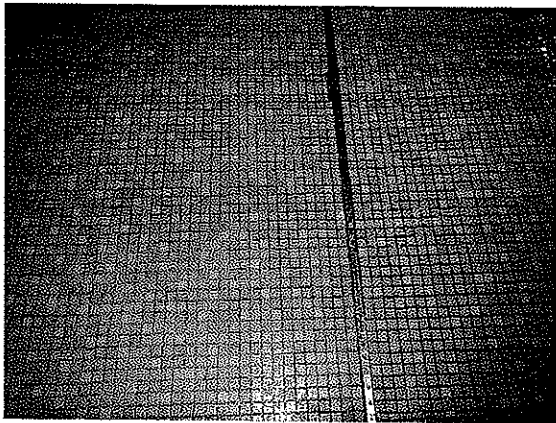
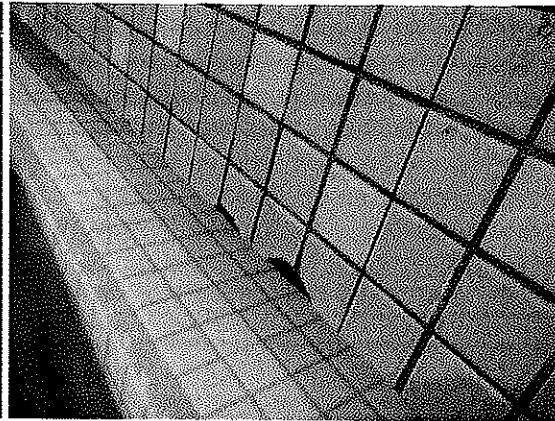
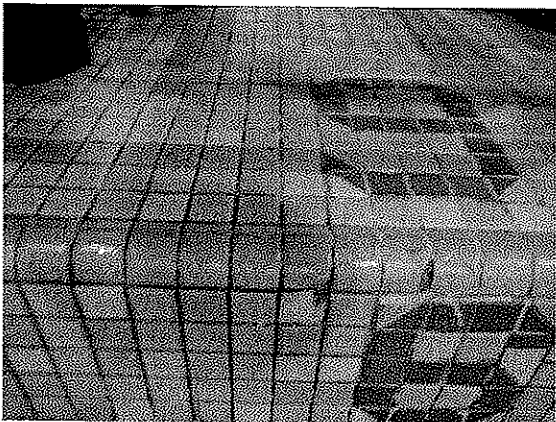
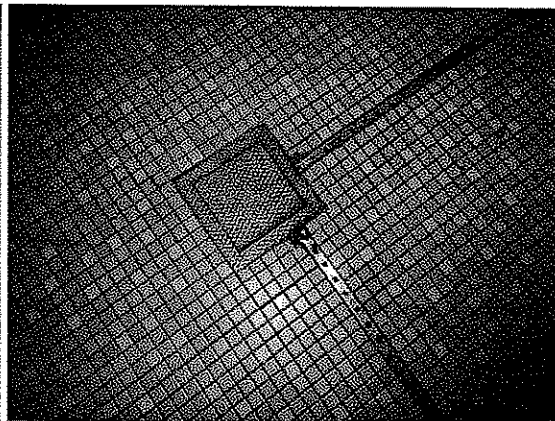
A. Deck

The pool deck is in fair condition with minimal observable cracks. The perimeter trench drain appears to be working effectively as standing water was not observed at the time of the site visit. There were areas of the deck/tile gutter connection that had sharp edges that could cause injury to pool guests, as well as a few areas where the tile had been chipped or in some instances popped off.

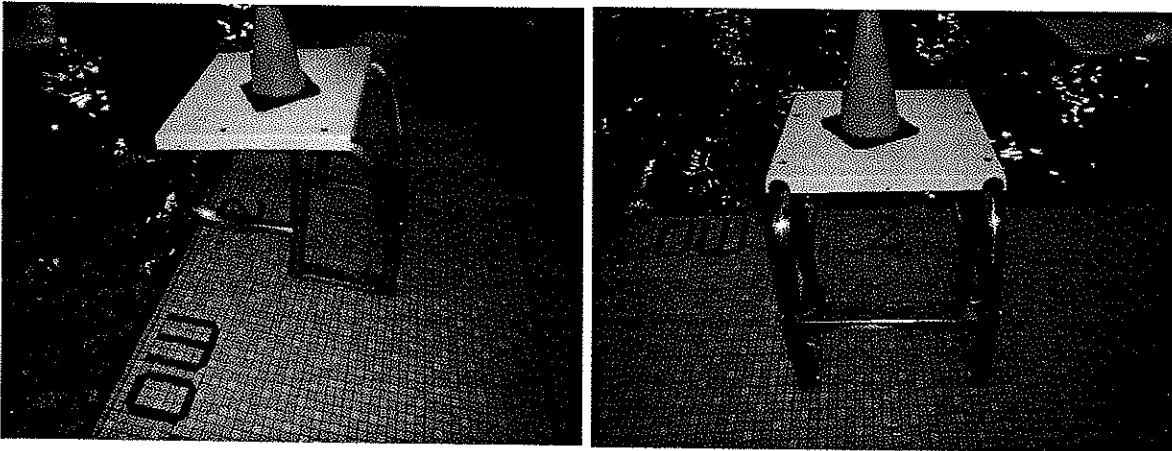
B. Starting Blocks

The pool has nine (9) starting blocks that are interchangeable and moved in between the shallow end and deep end of the pool, depending on the course length used by the competitive swim teams. This depth requirement meets the National Federation of High School Swimming (NFHS) requirement of a 4 foot minimum depth of water and that the blocks are a maximum of 30 inches above the surface of the water.

The starting blocks are an older model that does not meet the current expectations for competitive swimming. Today's industry standard for starting blocks includes dimensions of 24" x 32" for the platform. The current blocks are 22 x 22 which is close to the minimum standard for starting blocks.

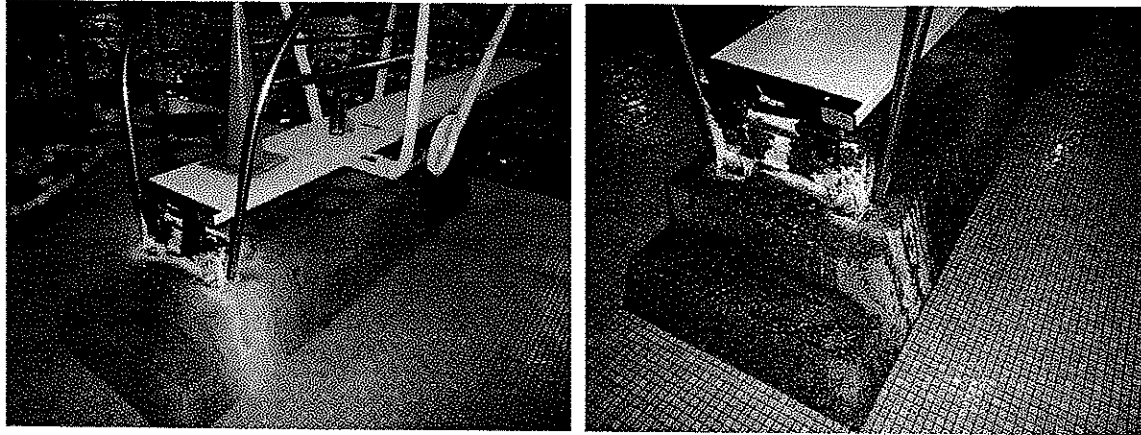
C. Diving Boards

A single 1-meter diving board is provided. The board is mounted on a concrete pedestal and is in good condition. When comparing the existing diving well dimensions to the dimensional requirements of NFHS, FINA and the NCAA, the following items were observed: (diagrams illustrating these items are found below)

The pool meets the current 1-meter depth/slope requirement for NCAA, FINA and High School.

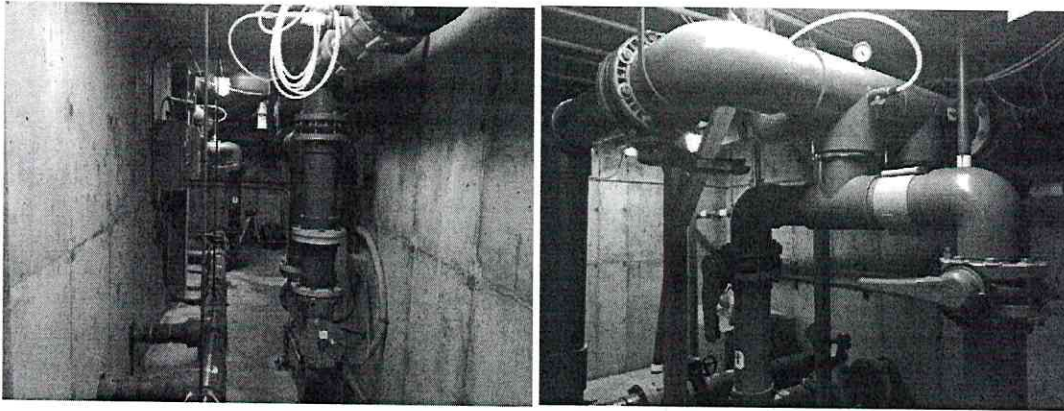
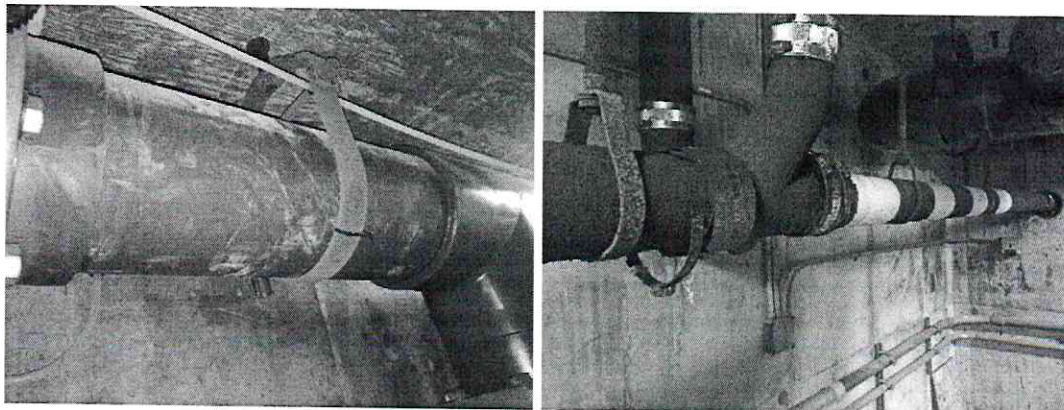
A. Piping

The visible, above ground recirculation piping for the pool in the pool mechanical room is Schedule 80 PVC piping, which is in good condition. The visible piping in the mechanical room leading to and exiting the pool is Schedule 80 PVC and staff report the gutter drain pipe is PVC for several feet before turning at a PVC elbow. Corrosion is noticeable at some of the pipe connections both the bolts and the valves, but overall the majority of piping and connections are in good condition. There is visible corrosion on several of the pipe supports throughout the mechanical room, and the pipe from the sanitary drain system has significant corrosion. Directional arrows are provided on the exposed piping as per industry standards. The valves in the mechanical room have been replaced as necessary. Several of the overhead pipe supports show significant signs of corrosion.

With a pool of this age it is not uncommon that some of the underground piping has corroded to the point of failure. The corrosion build up on the interior of the pipes also impact pipe velocities and could be contributing to the pool surface staining. A camera test could be done to determine the integrity of the piping.

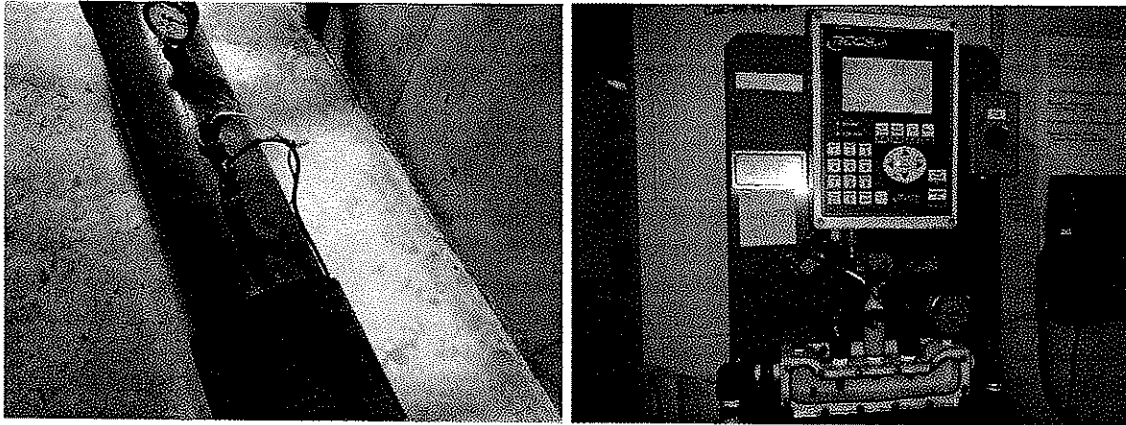
C. Flow Meter

There are two flow meters installed on the pool, one is an acrylic flow meter and is installed on the pressure piping back to the pool, downstream from the filter, which is the preferred place for mounting. The other is tied directly into the BecSys chemical controller. Flow sensors should be installed with at least ten pipe diameters downstream and five pipe diameters upstream on a straight run of piping.

The flow meter was giving a reading of 803 GPM which places the turnover at 5.8 hours. According to the Washington State Code, "Owners of swimming pools shall design and maintain water treatment recirculation rates to completely turn over the entire pool water volume of pool in six hours or less." The Fidalgo Pool meets this requirement.

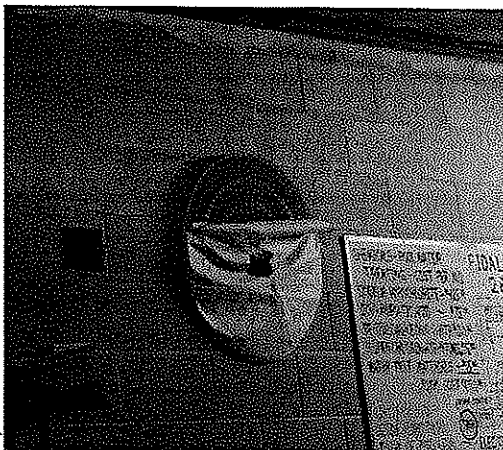
D. Filtration System / Surge Tank

The pool uses open-air vacuum Diatomaceous earth (DE) filters for its filtration. This system was installed during the initial construction. While these filters have served the facility well and provided ample water quality over the years, it is an antiquated system and should be replaced during a facility renovation with either high-rate sand filtration or regenerative media filtration.

The size and capacity of these filters could not be verified by nameplate on site during the audit, but staff notes have estimated each disc at 26 inches of diameter, equaling 121 SF of total surface area. The standard flow rate for this type of filtration system is to stay within 1 to 3 GPM/SF of surface area. With a flow rate of 803 GPM, the filtration rate is calculated at 6.6 GPM/SF which exceeds the industry standard for this type of filter by more than double.

Washington State Code requires the capacity in gallons of the surge tank to equal the square footage of the pool. This would require the surge tank to hold 5,040 gallons.

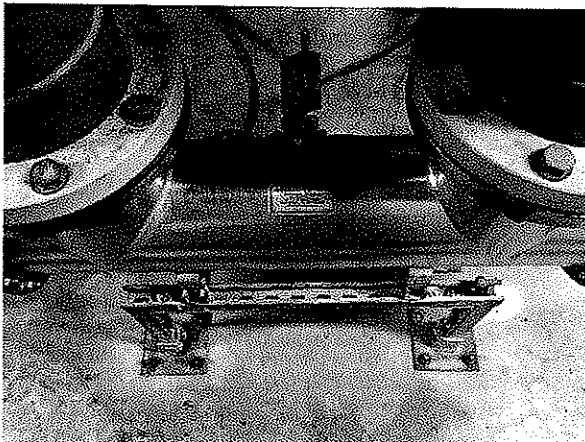
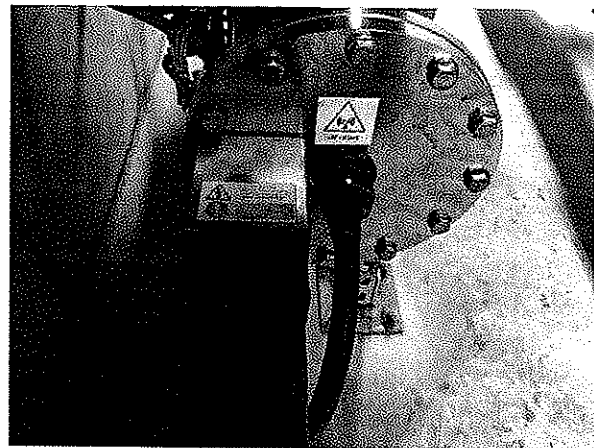
E. UV System

The pool mechanical system contains a Hanovia Ultraviolet Light Water Treatment System (UV). UV becomes beneficial in water treatment applications due to its ability to eliminate combined chlorine (also known as "chloramines") and kill chlorine resistant pathogens. While UV does break down free chlorine, the good form of chlorine used for pool disinfection, it is still highly recommended due to its ability to eliminate chloramines. Lower levels of chloramines lessens the corrosive off-gassing which attributes to the corrosion of deck equipment, HVAC, and internal structures of some facilities. Additionally, chloramines are typically responsible for the odor and irritation experienced by athletes, coaches and staff.

Eliminating chloramines creates a healthier and more enjoyable environment for facility users and staff. A UV system should be included in any future mechanical system renovations, or the construction of a new aquatic facility. Not only will UV systems kill pathogens and chloramines, but they will also eventually provide cost savings. It is common for a UV units to help lengthen and enhance the life expectancy of building materials, dehumidification units, etc. due to the elimination of combined chlorine before it is released into the air and causes corrosion of these materials.

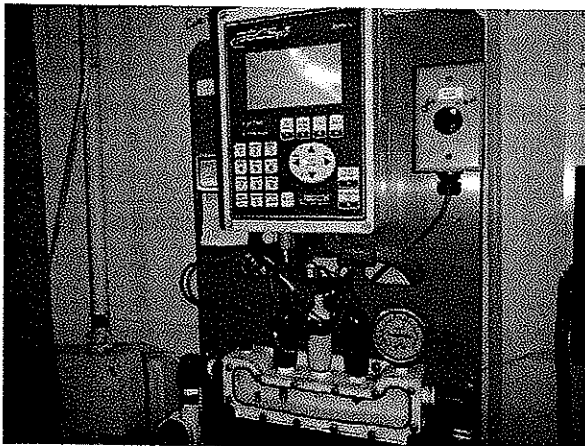
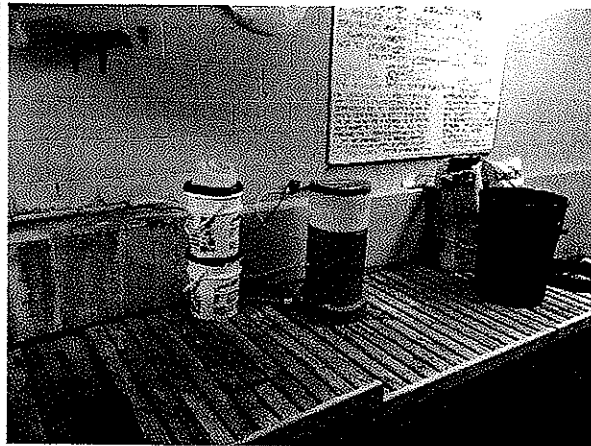
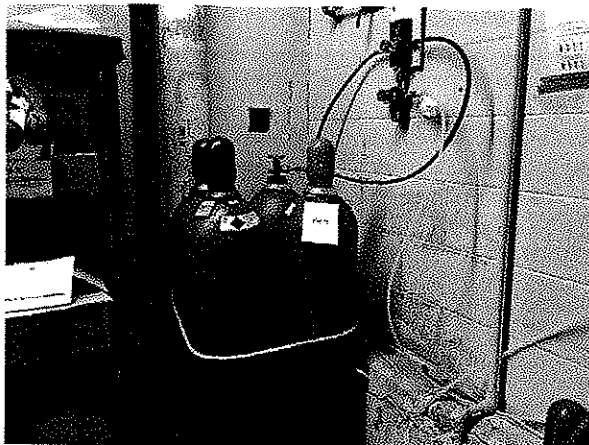
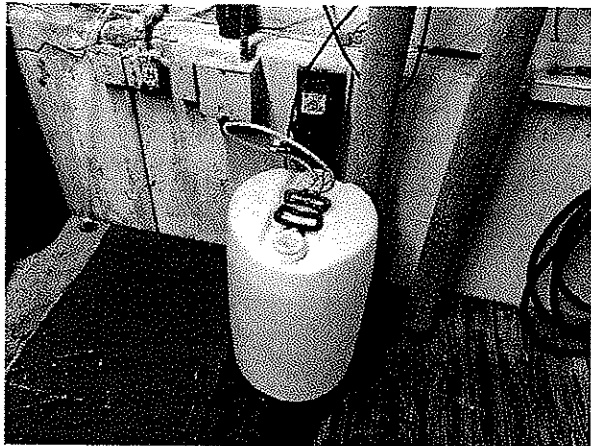
F. Chemical Treatment System

Currently the pool chemicals are located in the same area as the pool mechanical room. The pool is sanitized with Calcium hypochlorite (tablet chlorine) through a Pulsar 3 system and both CO2 and muriatic acid are used as the pH buffer. The 50 lb. buckets of calcium hypochlorite are stored inside the pool mechanical room on a platform above the surge tank. The muriatic acid and CO2 are stored in the same area, next to the chemical controller.

According to the Washington State Code, "Owners shall provide a separate chemical storage area or room that conforms to manufacturer's requirements for each chemical used in the pool area." A separate dedicated and ventilated chemical storage room for both the sanitizer and pH buffer is recommended and is the current industry standard. The existing chemical storage area does not meet the current requirement or standard. Dedicated chemical storage spaces should be included in any future plans, whether for a renovation or a new facility.

The pool is controlled by a BecSys 5 chemical controller. The chemical controller automatically adds chlorine and the pH buffer, maintaining the proper chemical balance throughout each day. The controller is in good working condition and is appropriate for this type of usage.

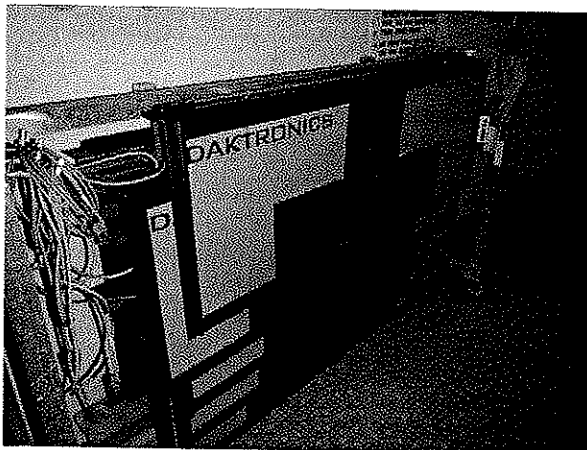
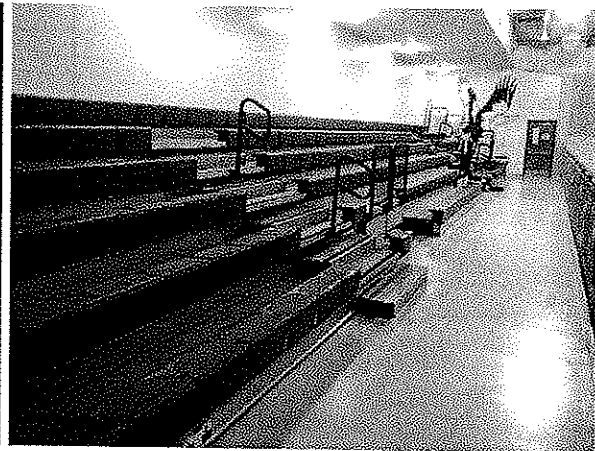
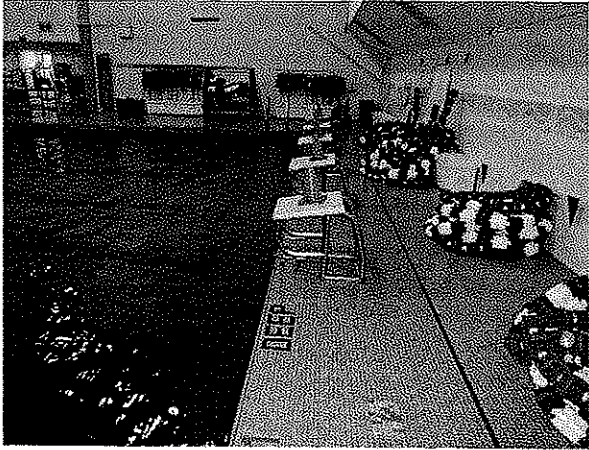
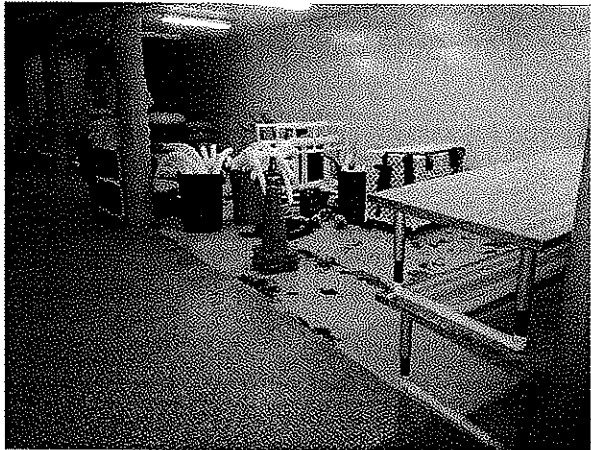
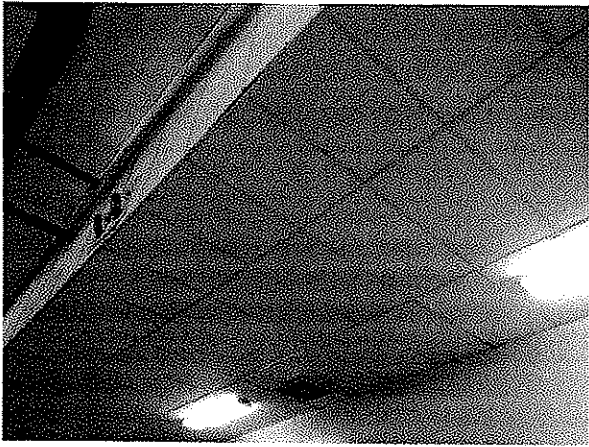
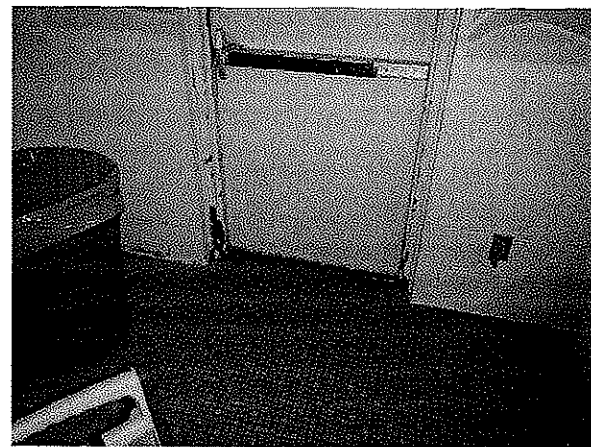
G. General Observations

- There is not enough storage space at the Fidalgo Pool and Fitness Center. Currently the pool deck is used for storage for items such as the Daktronics timing equipment, lane ropes for the 25 meter course length, and swim lesson equipment (such as kickboards, floats and underwater benches).

- The first two rows in the upstairs spectator seating for the swimming pool are not able to see the first two lanes during swim meets.
- Staff report that 60% of the ceiling material in the Fidalgo Pool has been renewed within the last 5 years with the entire south and east walls being new. Ceiling panels in a natatorium are usually made of galvanized steel with a coating of high-build epoxy coating. Other materials can be precast concrete, wood or aluminum. As with other materials in a natatorium, acoustical wall and ceiling must be corrosion resistant and interface with a vapor barrier, if necessary.

- User groups reported the air quality in the second-level spectator seating area is poor. Spectator areas should have higher air velocities of cool air (40 ft/min to 50 ft/min). Ceiling fans have also been used to improve spectator comfort. High velocity warm air in the face of spectators can be uncomfortable; therefore, cool air should be introduced over any raised spectator gallery for a major venue facility.

- Significant corrosion exists around the door frame on the east wall of the natatorium.
